# When the Tramlines are Missing

Sometimes it is hard to tell the orientation of a core based on sedimentary features alone. That is not the case for the Ness Formation from the Northern North Sea.

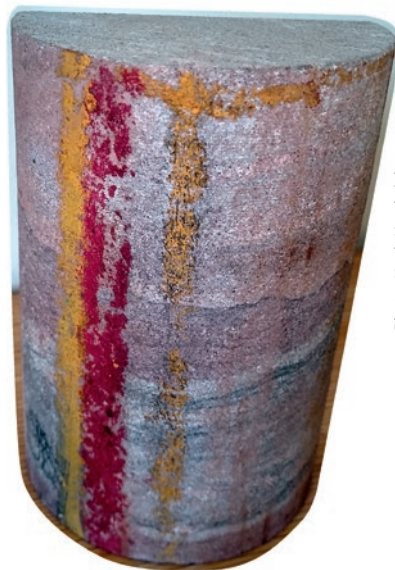
This core shows a good example of tramlines, with the red and yellow lines clearly marked on the outside. The red line should always be on the right.

In order to help geologists orientate cores correctly in terms of what is up and what is down, the outside of the core is often marked with a red and yellow line, the so-called tram line. Red is right, yellow is left.

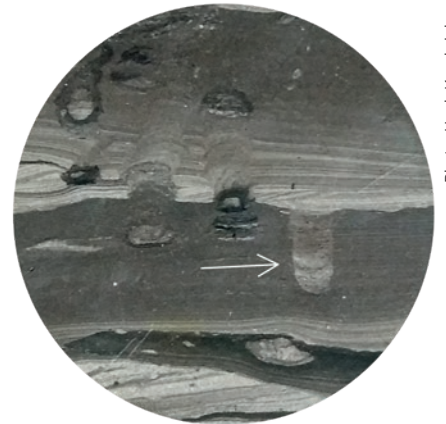
Close-up of a Ness core showing burrows that clearly indicate what the orientation of the core needs to be.

Due to subsequent sediment compaction, the original mostly vertical burrows now often show up as a squiggly line, but that does not take away the possibility to discern the starting point from where the digging started.

If the laminated fine sands cannot already be the clue towards putting a Ness core in the right orientation, then there are trace fossils that can do the job. What is generally thought of being the work of *Diplocraterion*, these bottom-feeders dug their way into the soft sediments of the Brent delta plain.

Very often, it is a slightly sandier bit that formed the starting point of a new burrow, clearly enabling people to conclude what is up and what is down when looking at a bit of Ness. Even when the tramlines are missing. ■
